Empire Pass Master Owner's Association

Level 2 Reserve Study

Report Period - 01/01/2021 - 12/31/2021

Type of Study	Update w/Site Visit
Date of Property Inspection	6/11/2020
Prepared By	Dale Gifford
Analysis Method	Cash Flow
Funding Goal	Full Funding

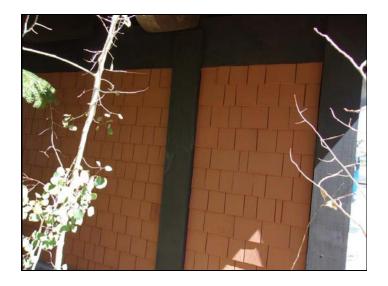
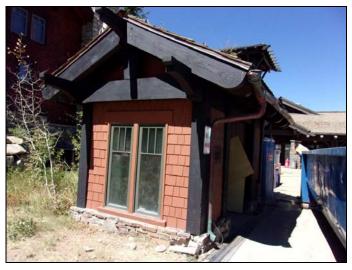
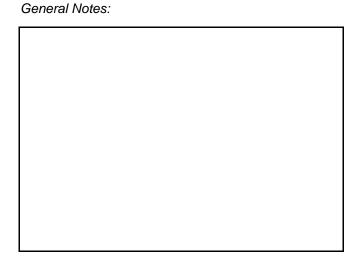
Comp #: 217 Transit Center - Repair/Repaint

The painted wood siding surfaces are in fair condition. We recommend funding to repair/repaint this component approximately every 4 - 6 years. Remaining life based on current age and condition.

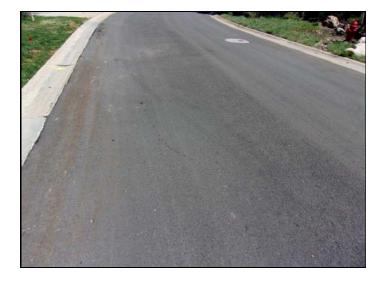
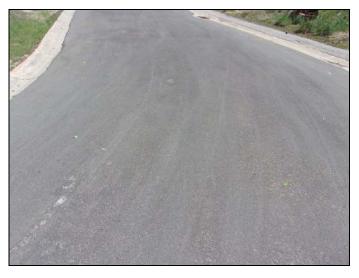
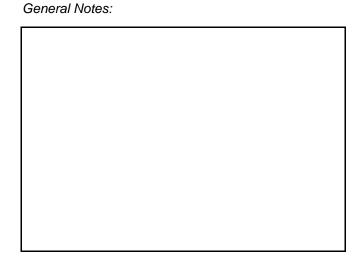
Comp #: 401 Asphalt - Empire Club Drive - Major Rehab

The asphalt surfaces are in good condition. We recommend funding for a major rehab of this component approximately every 25 - 30 years. Remaining life based on current age.

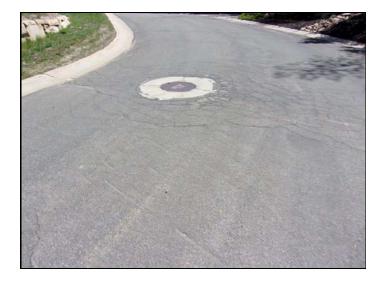
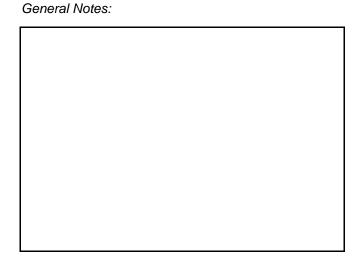
Comp #: 401 Asphalt - Hawkeye Place - Major Rehab

The asphalt surfaces are in good to fair condition. We recommend funding for a major rehab of this component approximately every 16 - 20 years. Remaining life based on current age.

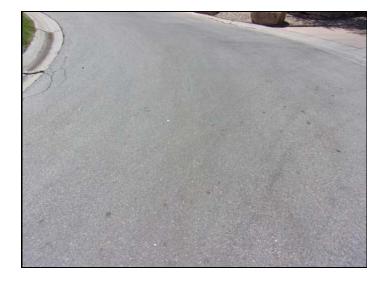
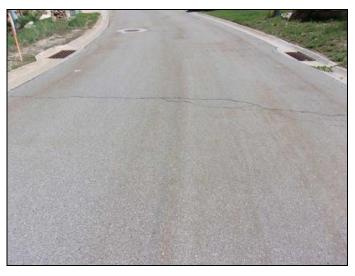
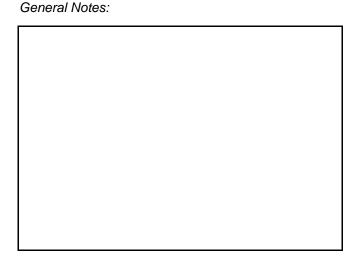
Comp #: 401 Asphalt - Silver Strike Trail - Major Rehab

The asphalt surfaces are in good condition. We recommend funding for a major rehab of this component approximately every 16 - 20 years. Remaining life based on current age.

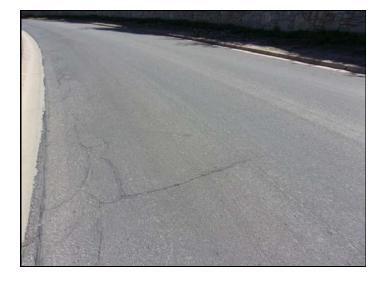
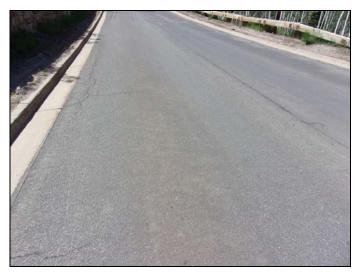
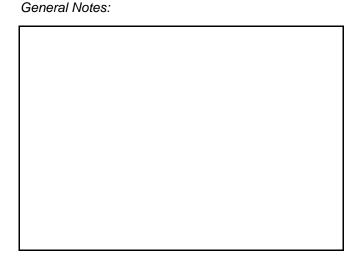
Comp #: 401 Asphalt - Twisted Branch - Major Rehab

The asphalt surfaces are in good to fair condition. We recommend funding for a major rehab of this component approximately every 16 - 20 years. Remaining life based on current age.

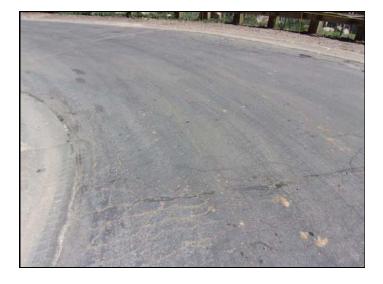
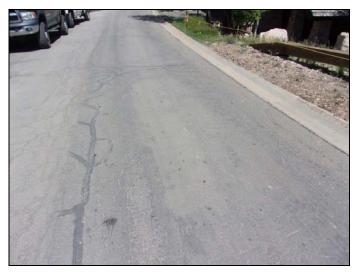
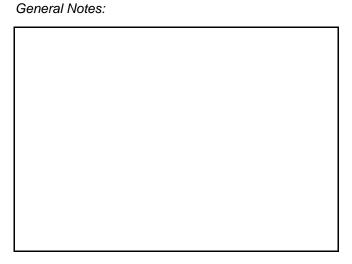
Comp #: 401 Asphalt - Village Way - Major Rehab

The asphalt surfaces are in good to fair condition. We recommend funding for a major rehab of this component approximately every 16 - 20 years. Remaining life based on current age.

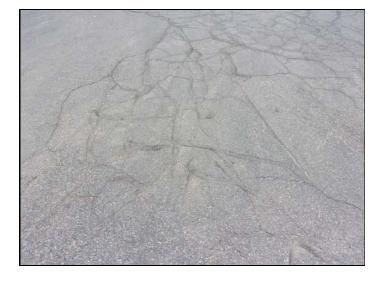
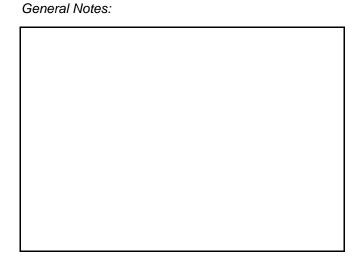
Comp #: 402 Asphalt - 2018 - Slurry Seal

The asphalt seal coat is in poor condition. We recommend funding to seal this component approximately every 3 - 5 years. Remaining life based on current condition.

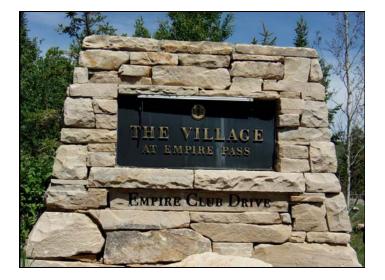
Comp #: 801 Monument Signs - Refurbish

The monument signs are in good to fair condition. We recommend refurbishing this component approximately every 15 - 20 years. Remaining life is based on current age and condition.

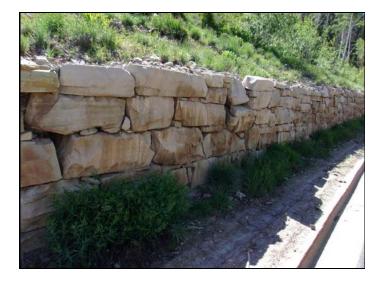
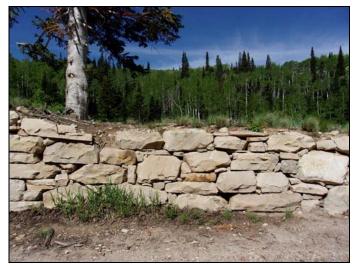
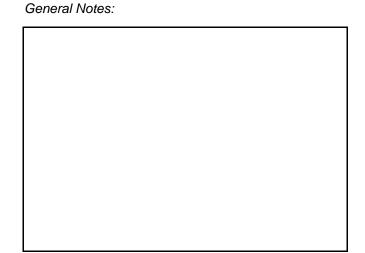
Comp #: 1890 Retaining Walls - Repair

The retaining walls are generally in good condition. Although this component has an extended useful life, we are funding to make minor repairs every 10 years. Remaining life based on current age.

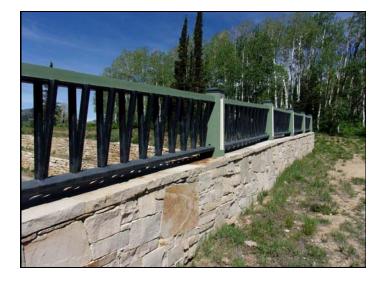
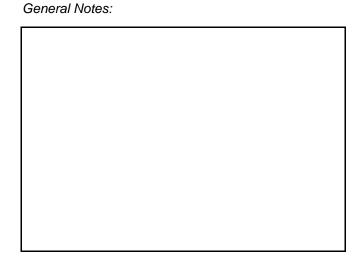
Comp #: 2302 Metal Bridge - Maintenance

Research with the client reveals the metal bridge is in good condition. Regular maintenance is performed annually as an operating expense. More significant maintenance is performed approximately every 4 years.
