Empire Pass Master Owner's Association

Level 2 Reserve Study

Report Period - 01/01/2021 - 12/31/2021

Type of Study	Update w/Site Visit
Date of Property Inspection	6/11/2020
Prepared By	Dale Gifford
Analysis Method	Cash Flow
Funding Goal	Full Funding

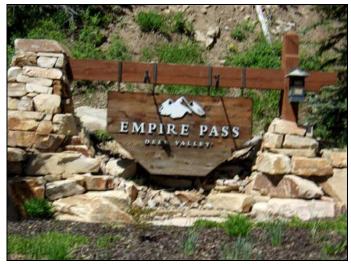
Comp #: 801 Monument Signs - Refurbish

The monument signs are in good to fair condition. We recommend refurbishing this component approximately every 15 - 20 years. Remaining life is based on current age and condition.

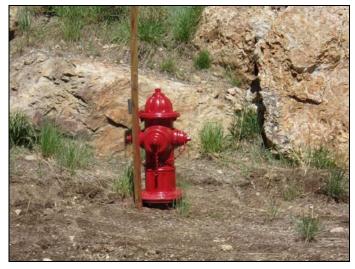
Comp #: 990 Fire Hydrants - Repair/Replace

The fire hydrant system is in working condition. We recommend funding to make repairs/replacements to this component approximately every 3 - 5 years. Remaining life based on current age.

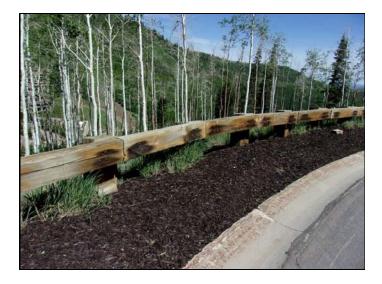
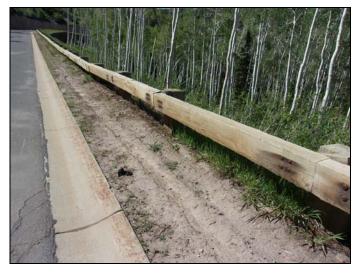
Comp #: 1007 Guard Rails - Repair

Research with the client reveals this component is inspected and repaired yearly.

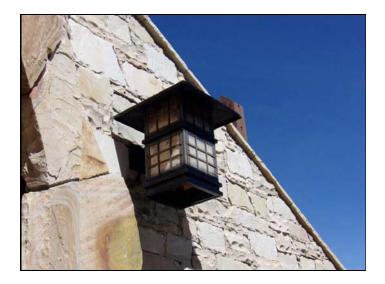
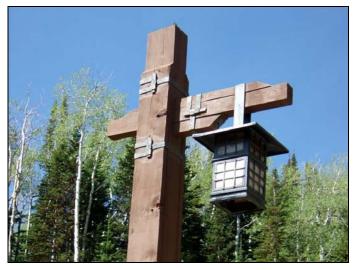
Comp #: 1604 Bridge & Pole Lights - Replace

The bridge and pole lights are in good condition. Although this component may reach an extended life, we recommend funding to completely replace this component approximately every 15 - 20 years. Remaining life based on current age and condition.

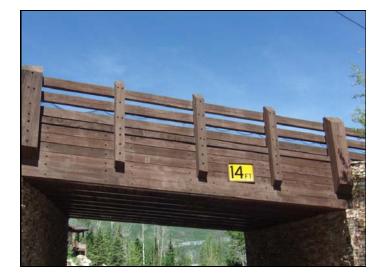
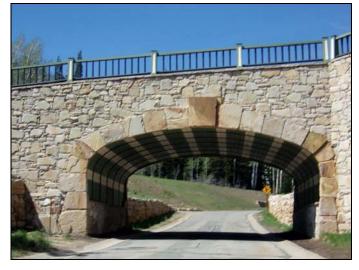
Comp #: 2302 Bridges Surfaces - Refurbish

The bridge surfaces are generally in good condition. We recommend funding an allowance to refurbish this component approximately every 20 years. Remaining life based on current condition.

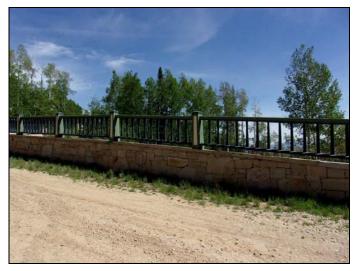
Comp #: 2302 Metal Bridge - Maintenance

Research with the client reveals the metal bridge is in good condition. Regular maintenance is performed annually as an operating expense. More significant maintenance is performed approximately every 4 years.
